Missouri
Department of
Natural Resources

Stream Survey Sampling Report

**Phase II
Hinkson Creek Stream Study
Columbia, Missouri
Boone County**

July 2004-June 2005

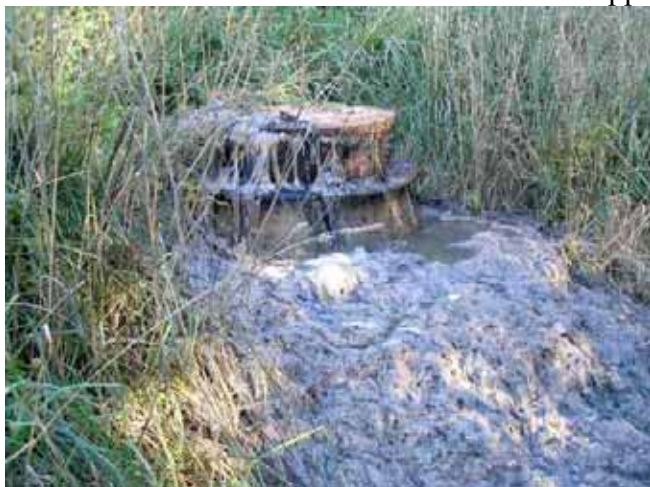
Photo 1.

- Periodic sewer line breaks and/or bypasses can contribute to elevated in-stream *E. coli* readings. The following are examples of some occurrences.
 - On at least one occasion a sewer line bypass occurred during the study. The bypass occurred at a manhole located behind the Wal-Mart store located in the Broadway Market Place shopping complex on August 10, 2004. The sewer lines had become plugged with tree roots and grease, which caused raw wastewater to overflow from the manhole and enter Hinkson Creek (refer to Appendix B, Photos 1-3).

Raw wastewater discharging from manhole located behind Wal-Mart in the Broadway Market Place Shopping Complex.

Sewer line had become clogged by tree roots and grease causing wastewater to back up into the manhole.

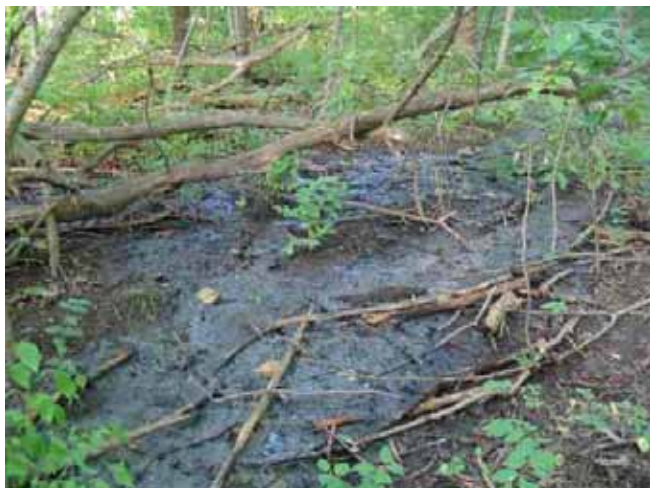
Photo 2.

Raw wastewater overflowed from the manhole and downhill through a wooded area before collecting in a backwater area of Hinkson Creek.

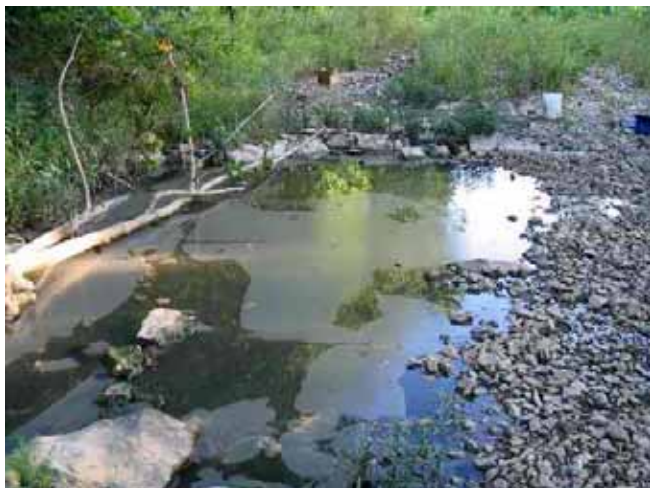
Photo 3.

The raw wastewater that pooled in the backwater area of Hinkson Creek then seeped through the gravel bar and entered main-stem Hinkson Creek.

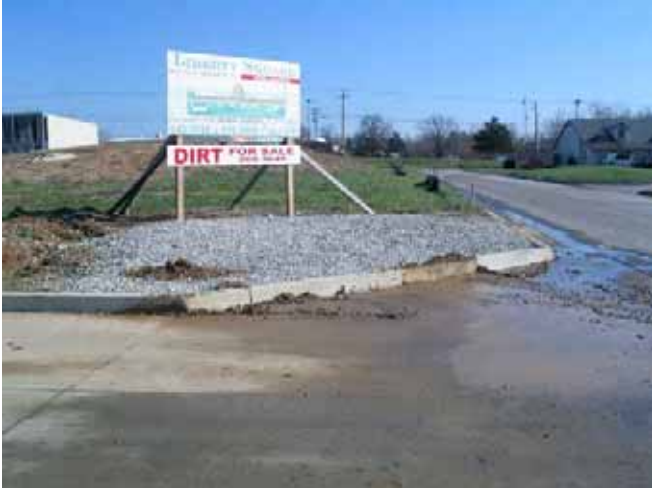
Photo 4.

On-going construction activity was occurring near the Home Depot building supply store. Construction of Liberty Square, among other activities in the area, was occurring at the time of this study. An accumulation of sediment on the roadway during the construction of Liberty Square can be seen.

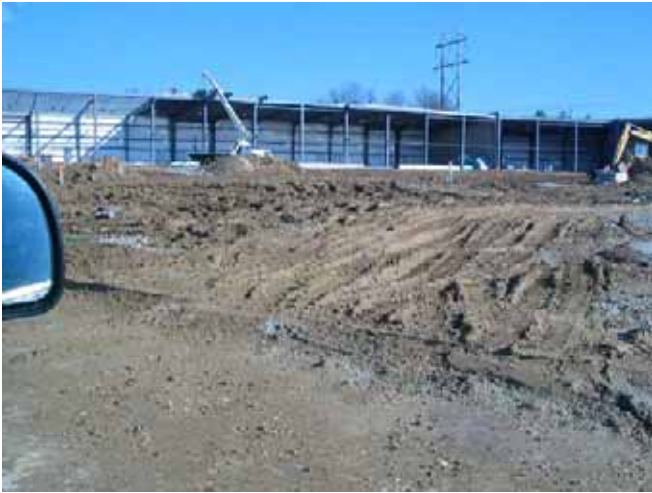
Photo 5.

Accumulation of sediment on the roadway during the construction of Liberty Square.

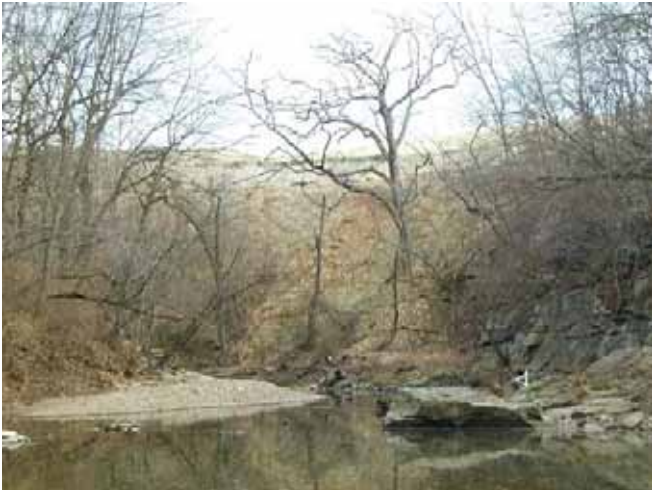
Photo 6.

- Upstream of the Broadway bridge crossing, there is on-going construction activity along the upper east bank of Hinkson Creek across from Stephen's Lake and downstream of the old Mega Market drainage. Observations made in March 2004 and April 2005 found the bank to be slumping, creating a potential for soil to enter into Hinkson Creek (refer to Appendix B, Photos 6-7).

Photos 6 and 7 were taken upstream of the Broadway bridge crossing, where there is on-going construction activity along the upper east bank/hillside of Hinkson Creek across from Stephen's Lake Park and downstream of the old Mega Market drainage.

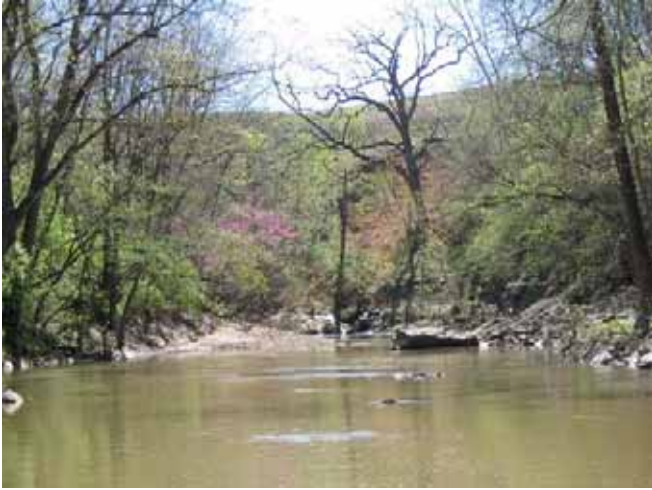
Photo 7.

It appears that the east bank/hillside is slumping into Hinkson Creek.

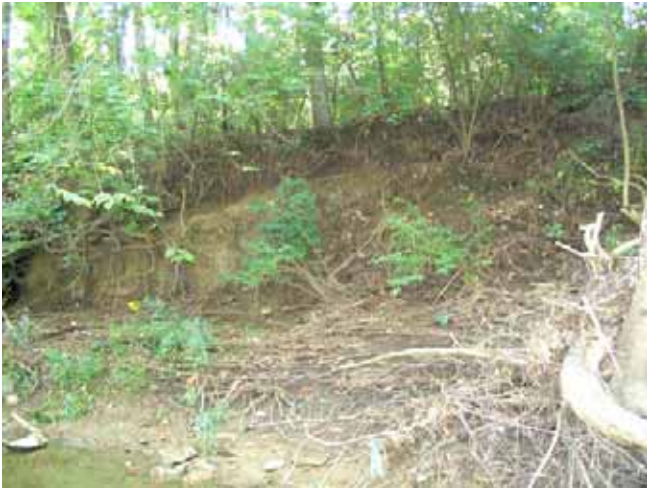
Photo 8.

- Throughout the study area, there is evidence that during high flow events the stream is cutting away at the stream banks creating erosion along Hinkson Creek. Higher than normal in-stream flows occur as more impervious surfaces (e.g., roadways, parking lots, and rooftops) are constructed throughout the watershed. In addition, to prevent flooding of roadways, buildings, homes, etc., stormwater runoff is conveyed via stormwater systems where it discharges directly into stream systems. As stream flows increase, the stream banks become undercut and eventually fail, causing soil, trees, and other debris to fall into the stream (refer to Appendix B, Photos 8-9).

Photos 8 and 9 were taken upstream of the Broadway bridge crossing and across from Stephen's Lake Park. Bank erosion is occurring along Hinkson Creek. During high flow events the water is cutting away at the stream banks, exposing tree roots and bare soil.

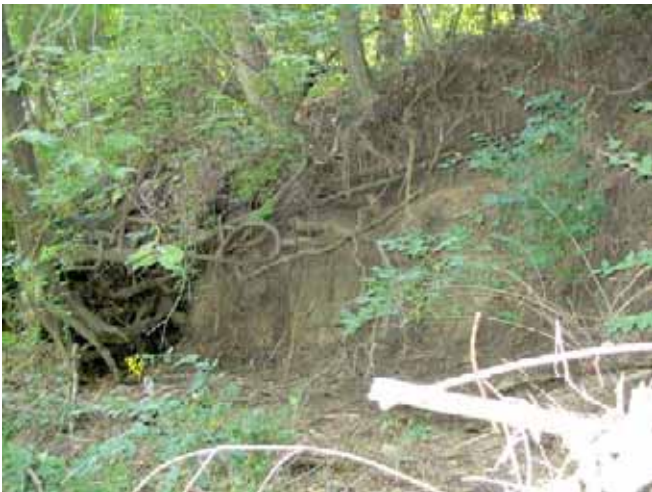
Photo 9.

If undercutting continues the stream bank will eventually fail and collapse into Hinkson Creek.

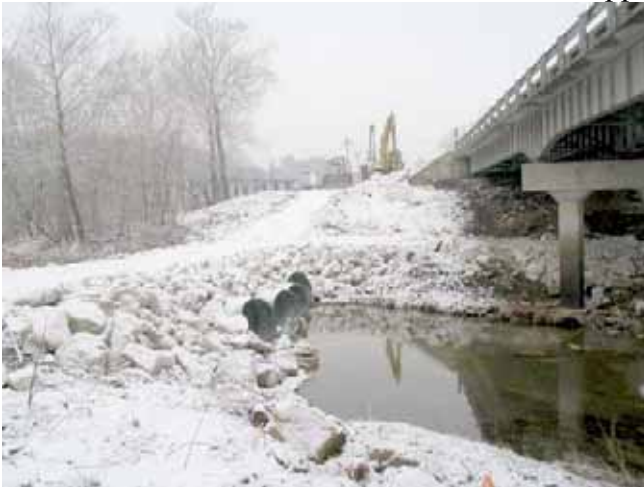
Photo 10.

Bridge construction at Broadway was occurring at the time of this study. A temporary rock bridge was constructed along the south side of Broadway to allow heavy equipment to pass from one side of the bridge to the other.

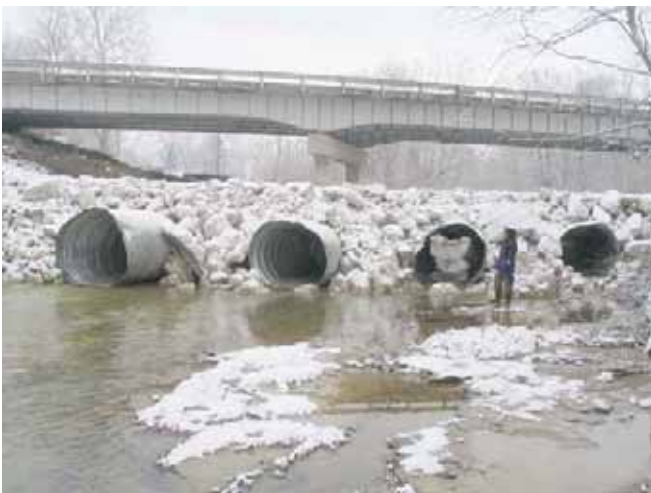
Photo 11.

During at least one high rainfall event the temporary bridge was removed by high water.

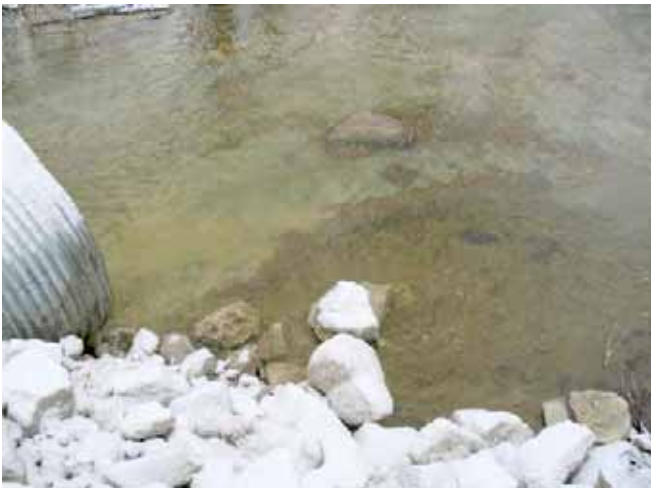
Photo 12.

Sediment accumulation along the south side of the temporary rock bridge. Sediment deposition could be a result of the bridge construction and/or other activities occurring further upstream.
