# **Hinkson Creek Collaborative Adaptive Management**

## **Physical Habitat Assessment Phase II: Field Component**

Final Report

March 1, 2015

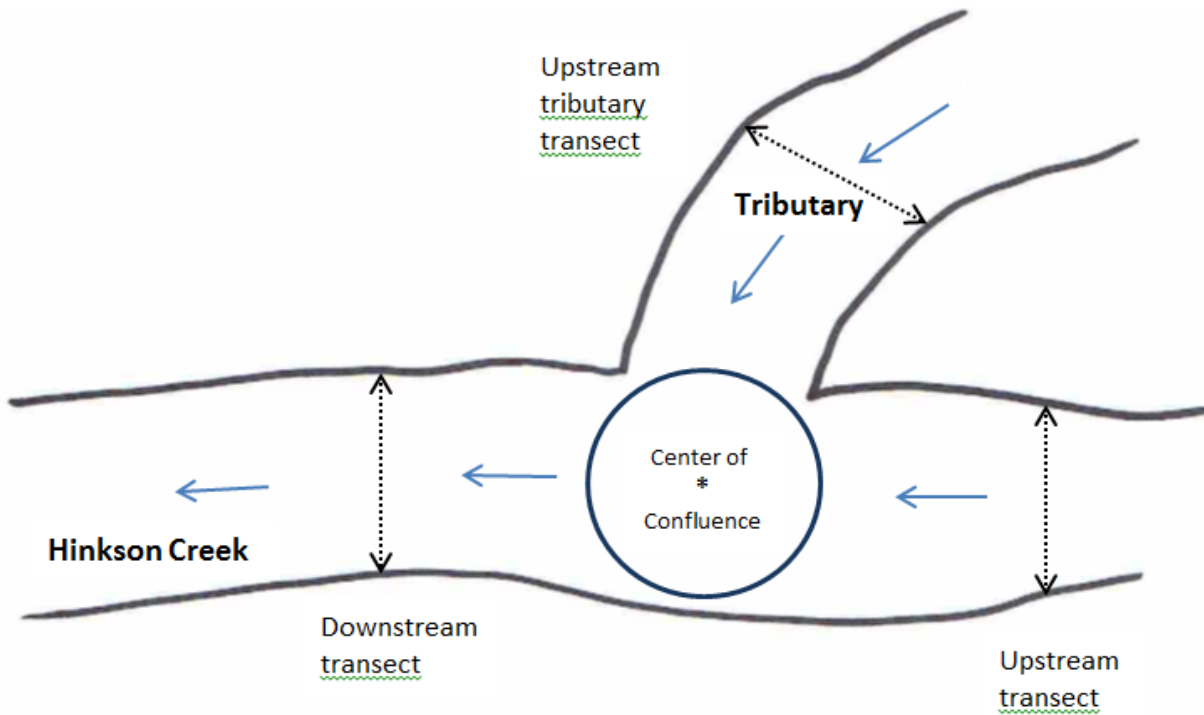
Figure 2b. Layout of three measured transects at confluence sites.

For purposes of the survey, the field protocol called for the survey cross section of the study plot at any confluence to be set in Hinkson Creek 5 m downstream of the downstream bank of the confluence with the tributary so that the study plot was as close to the confluence as possible. This placement of the survey transect proved to be impractical in the field, as the width of the

channel tended to be greater at the confluences, and the effects on physical habitat from the tributary flow were not evident at the 5 m distance. After consultation with Dr. Hubbard, the field team set three transects for each confluence: one upstream of the confluence in Hinkson Creek, one downstream of the confluence in Hinkson Creek, and a third upstream in the tributary. Transects were located 20 m to 50 m from the center point of the confluence, with all three distances being measured and recorded (Figure 2b). All bank and channel measurements described in this field protocol were collected at each of the three transects.

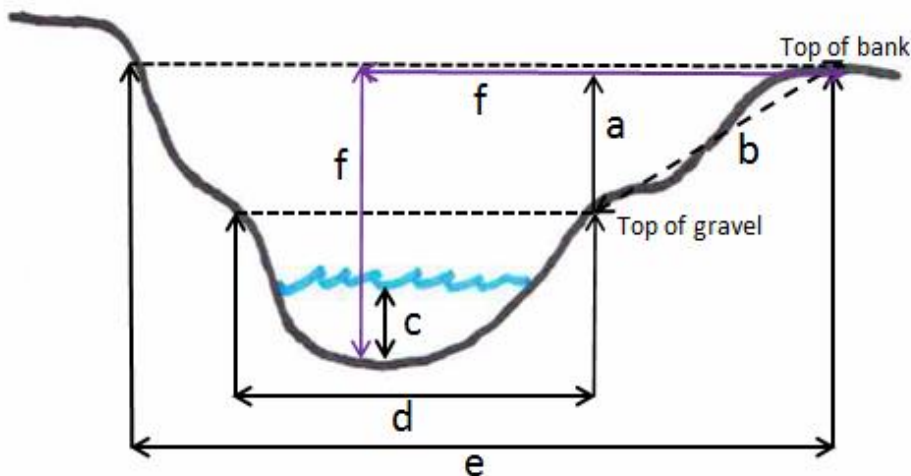
Figure 4. Cross-section view of measured channel dimensions: a) bank height, b) bank slope, c) thalweg depth, d) channel width, e) bankfull width, and f) relative thalweg depth (vertical) and thalweg position (horizontal).

#### 4.7.2 Procedure for measuring Channel Width, Wetted Width, Bankfull Width, Bank Height, Channel Depth, and Relative Thalweg Depth and Thalweg Position (Figure 4):

1. Using a laser range finder, the distance from the bottom of the bank (the top of the gravel from the streambed) was measured across the stream channel from one bank to the other (channel width). Also using a laser range finder, the distance from one side of the stream to the other (wetted width) was measured. If there was a split in the channel due to a bar or island, the following wetted width values were recorded where possible and applicable: entire width of wetted portion of stream, wetted width nearest to left bank, wetted width of center stream channel, wetted width nearest to right bank. Values for channel width and wetted width(s) were recorded on the data sheet.

2. To measure bankfull width, the bankfull level on the streambank with the highest terrace was located. For a description of bankfull indicators see Harrelson et al. (1994). While squatting at the top of the streambank with the lowest terrace (presumed bankfull), the

laser range finder was used to measure the width to the bankfull level on the opposite streambank.

3. Whether the right bank or left bank (descending) was used for bank measurements was determined at each survey point by which bank had the lower elevation (bankfull bank), and was indicated on the data sheet. Bank height was measured as the distance from the bottom of the bankfull bank (frequently determined by the top of the line of gravel from the streambed) to the top of the stream bank, using a laser level and an extension pole with a receiver.

4. Thalweg depth was measured by positioning the meter stick or extension pole on the stream bed at the deepest part of the channel and reading the depth of the water. In the event that the water was more than chest deep, a depth finder and battery with float were deployed for measuring thalweg depth.

5. Relative thalweg depth and thalweg position were measured relative to the bankfull bank. Relative thalweg depth was measured using a laser level and an extension pole with a receiver. The extension pole was set at the bottom of the stream in the thalweg, and raised or lowered until the receiver was on a horizontal plane with the laser level stationed at the top of the bank. Thalweg position was measured using a laser rangefinder to measure the distance between the top of the bankfull bank and the laser receiver on the extension pole.

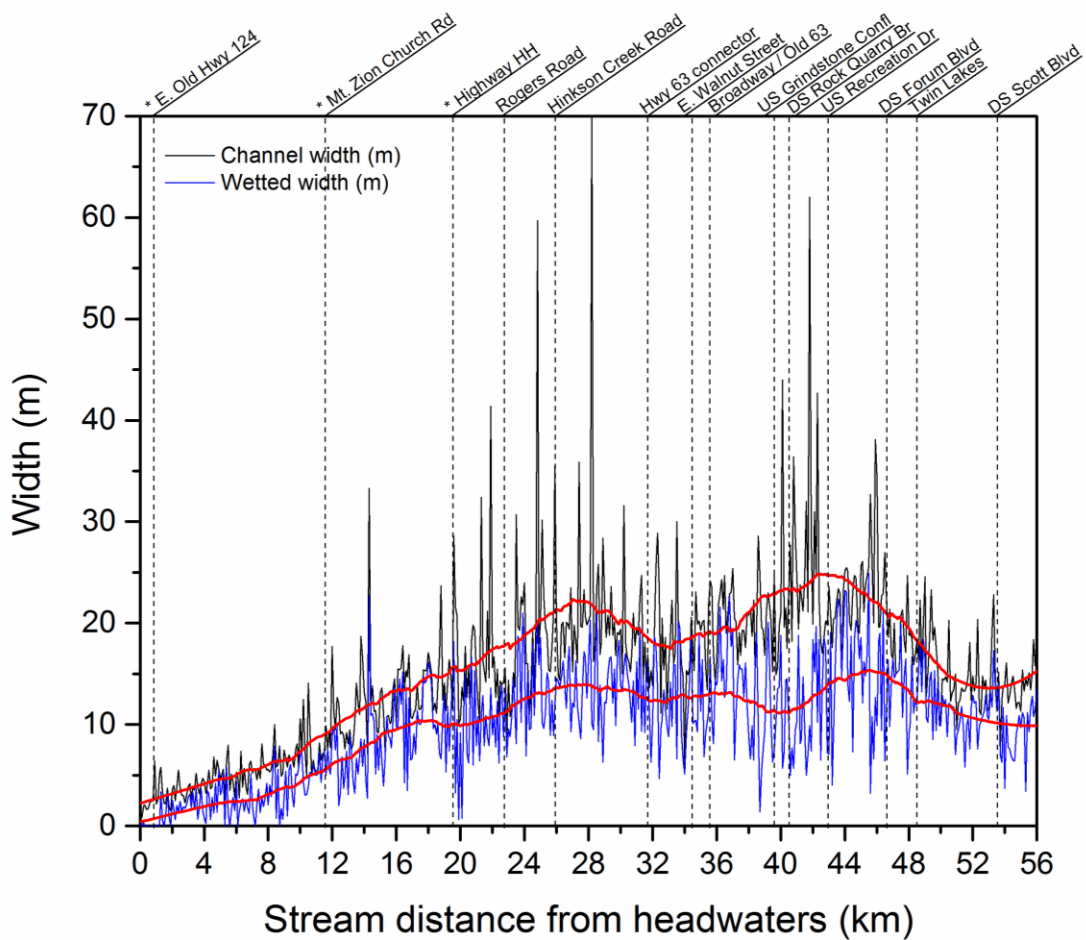
Figure 6. Channel width and wetted width as a function of stream distance for Hinkson Creek, with 100pt moving average shown in red.

Wetted width in Hinkson Creek is highly variable. It would therefore not be expected that there would be a strong relationship between wetted width measured during the Phase II PHA and channel width because wetted width is highly dependent on discharge characteristics at the time of measurement whereas channel width and bankfull width are related to persistent hydrologic conditions. A comparison of channel width and wetted width with stream distance is shown below (Figure 6).

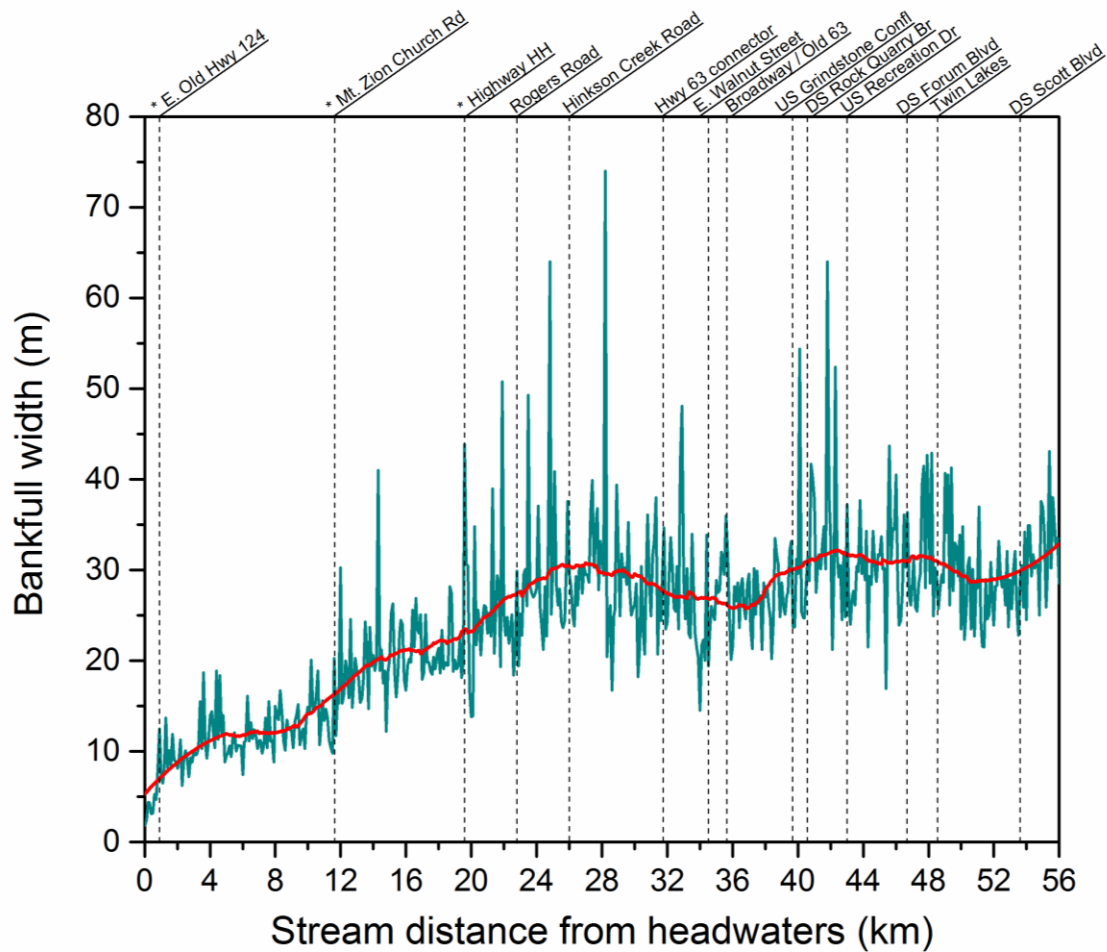
Figure 7. Bankfull width with stream distance in Hinkson Creek. The 100pt moving average is shown in red.

Bankfull width measured from the top of the bankfull bank across the channel to the bankfull height on the opposite bank shows a slightly stronger positive relationship with stream distance than channel width (Figure 7). One possible explanation for this trend is that channel incision may be occurring in response to land use changes upstream (Booth and Jackson 1997).

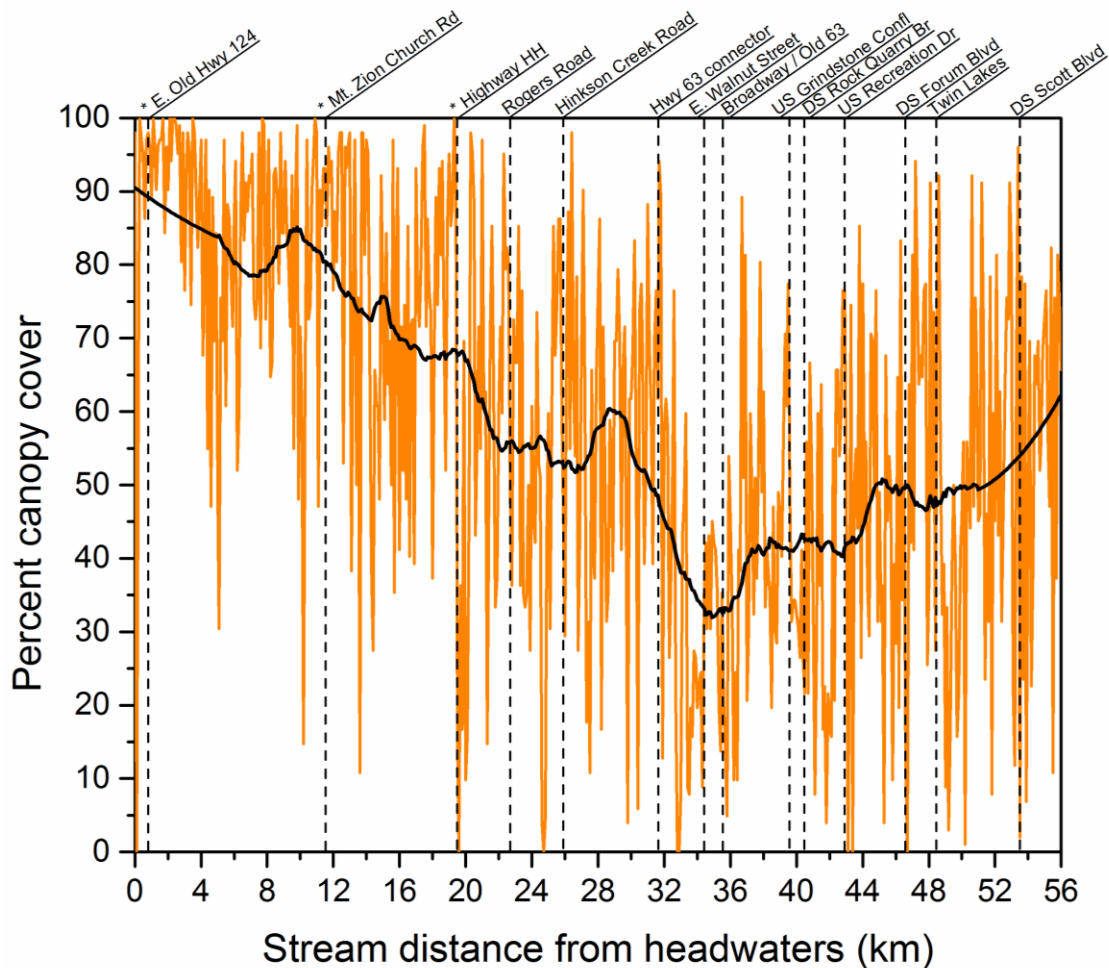
Figure 9. Percent canopy cover on each 100 m transect (average) with stream distance from headwaters, Hinkson Creek. The 100pt moving average is shown in black.

Average canopy cover was calculated for each 100 m survey point by averaging the six canopy cover measurements (at left bank; at center of stream: facing upstream, facing left bank, facing downstream, facing right bank; at right bank) and dividing that average number by 17 (the maximum number of points that could be covered on the modified convex densiometer) to calculate average percent canopy cover per site. The percent canopy cover at the 100 m survey points ranged from a maximum of 100%, to a minimum of 0%, with a mean of 59.5% and standard deviation of 27.4%. A graph of the average percent canopy cover with stream distance illustrates the variability from site to site from headwaters to mouth in Hinkson Creek (Figure 9).

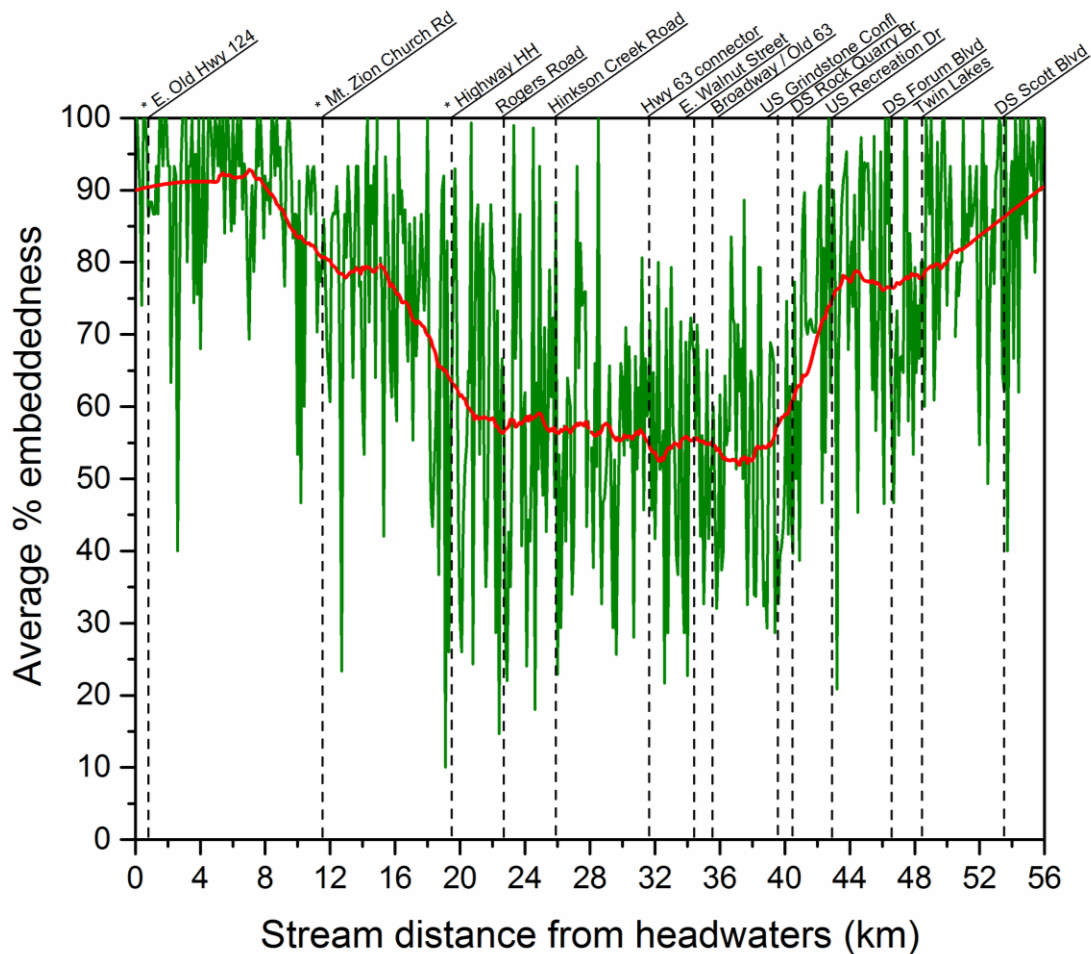
Figure 11. Average percent embeddedness for sampled particles (5) at each survey transect with stream distance from headwaters of Hinkson Creek. The 100pt moving average is shown in red.

Average percent vertical embeddedness was calculated from percent vertical embeddedness of the 15 particles collected during the pebble count at each 100 m survey transect. Average percent vertical embeddedness is graphed as a function of stream distance in Figure 11 below. Average percent vertical embeddedness at survey transects ranged from a maximum of 100% to a minimum of 10%, with a mean of 72% and standard deviation of 21%. The average percent vertical embeddedness at a survey transect was calculated to be 100% fifty-one times along the length of Hinkson Creek, or approximately 9% of the survey transects. A highly embedded streambed significantly reduces habitat available for virtually all macroinvertebrates except those that are burrowers (Rabeni et al. 2005). Based on the results from the PHA Phase II, Hinkson Creek appears to have reduced habitat heterogeneity available for macroinvertebrate habitat.

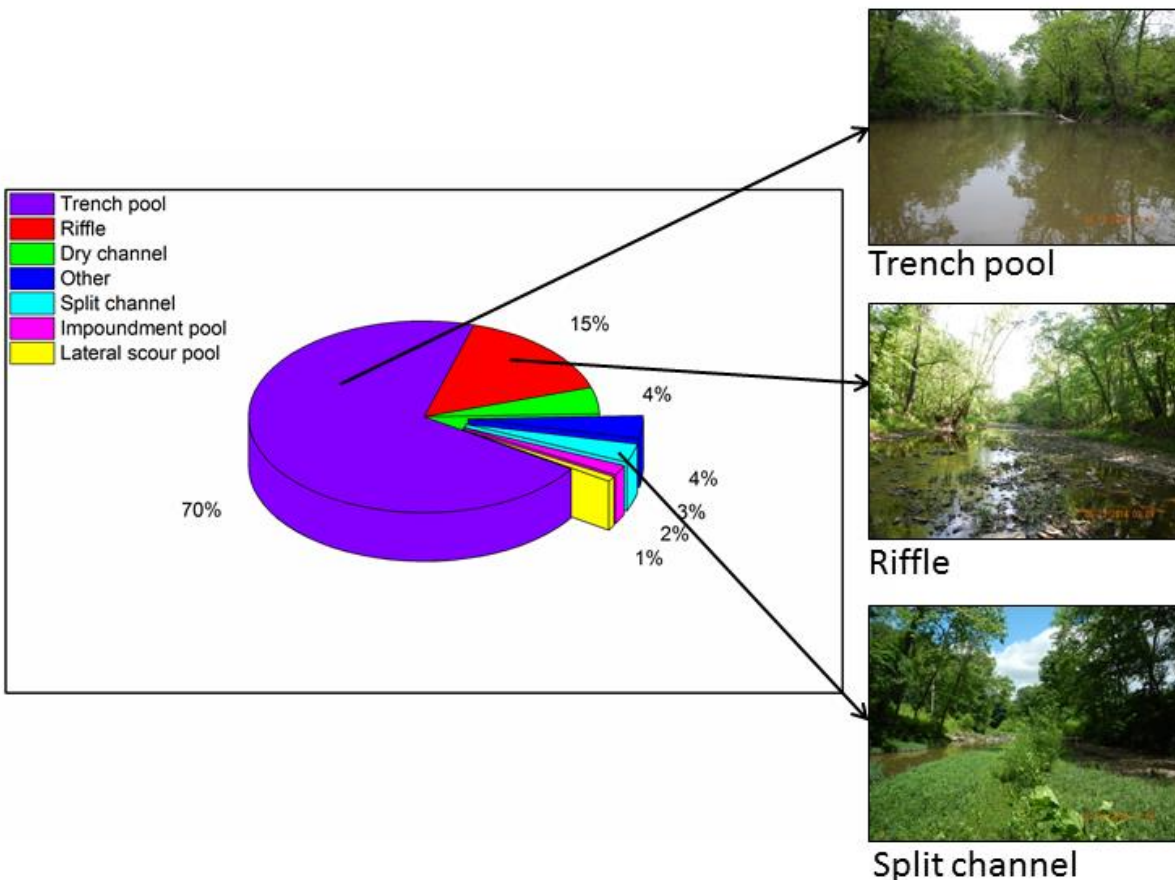
Figure 12. Breakdown of channel unit types in Hinkson Creek.

Alluvial streams are expected to exhibit certain morphological characteristics, including a sequence of channel unit types, particularly riffles and pools. The riffle-pool sequence is expected at regular intervals along the stream continuum. The Missouri Department of Natural Resources (MDNR) procedure for Semi-Quantitative Macroinvertebrate Stream Bioassessment states that riffles are expected to occur at a distance of 7 to 10 stream widths (wetted width) due to the effects of sinuosity and the influence of point bars on streamflow velocity (MDNR 2003). The results of Phase II of the PHA showed that trench pools are the dominant form of channel unit at 70% of channel unit types recorded (survey point, and then every ten meters between survey points). Given the MDNR standard, and the average wetted width of 9.8 m in Hinkson Creek, a riffle would be expected approximately every 68.6 to 98 m. Using the more conservative estimate, 816 riffles would be expected along the length of Hinkson Creek (14.6% of channel unit classifications given total measurements of 5,583). Using this calculation, the results in Figure 12 are slightly above expected riffle-pool frequency in Hinkson Creek. The breakdown of channel unit types is listed in table form in Table 7.
